Sustainable Civil Engineering Structures and Construction Materials, SCESCM 2016

Back calculation of excessive deformation on deep excavation

M. F. Ma'ruf^{a,*}, H. Darjanto^b

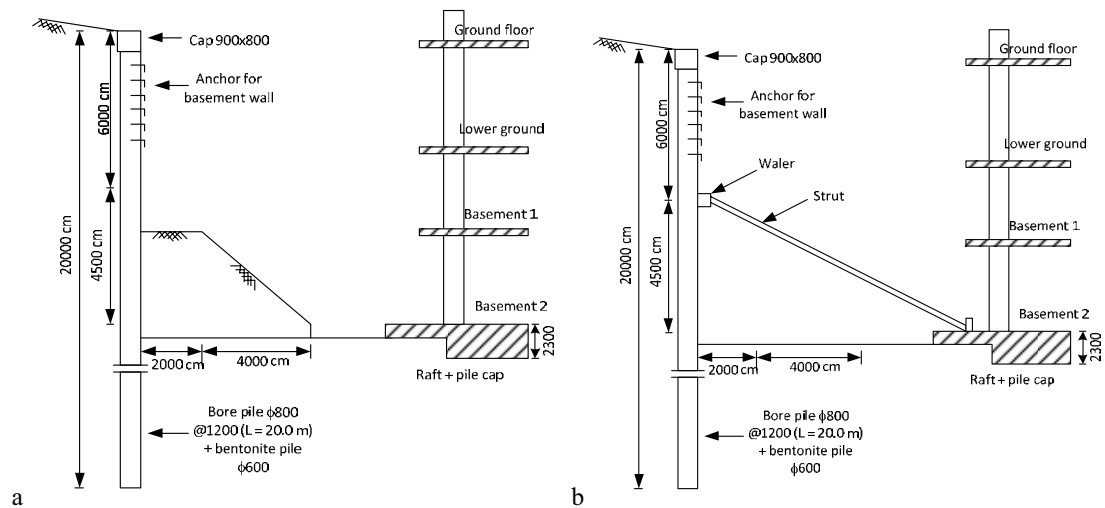
Fig. 3. The cut off wall system: (a) Counter front at 8 m depth; (b) Removal of counter front.

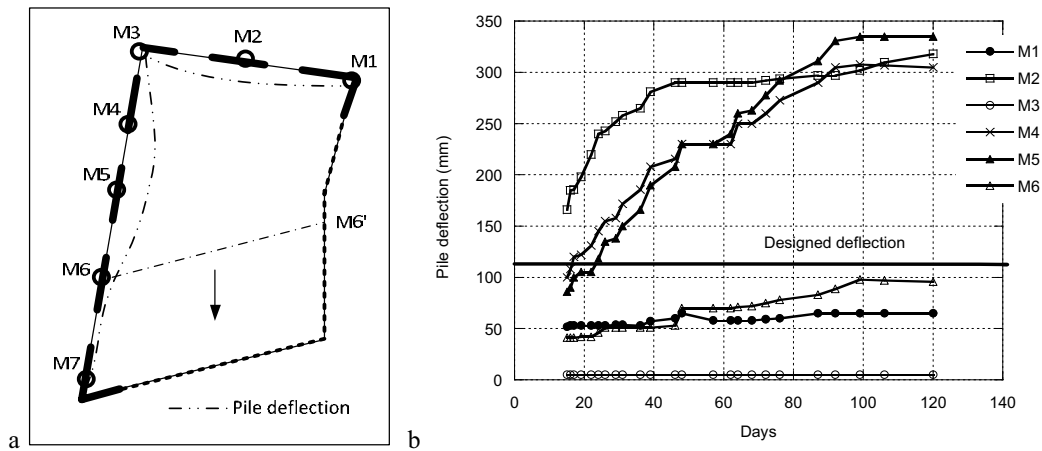
The excavation work was started after soldier pile installation completed. The monitoring sensors were installed at the top of the pile cap according to the layout as described in Fig. 4a. The available monitoring data were started at days 13 after excavation work. The excavation sequence was started from the onset of tower 1 and extended into all direction to get 8 m depth dredging up. The 12.8 depth excavation was conducted by setting the ground counter front along the pile wall. Starting at M6 – M6' was a sloping excavation following arrow direction from – 12.8 m depth at M6 – M6' to ground level at the project boundary.

The deflection behavior along the excavation process can be evaluated in Fig.4b. The deflection of the wall exceeded the designed criteria at the middle of the North wall and at the first one-third of the West wall. Even it reached more than twice of the targeted deflection about 30 days afterward. This excessive deformation was a red warning and need a quick counter measure to prevent excavation failure.

Fig. 4. (a) Monitoring points and deflection plan view; (b) Pile deflection curve.

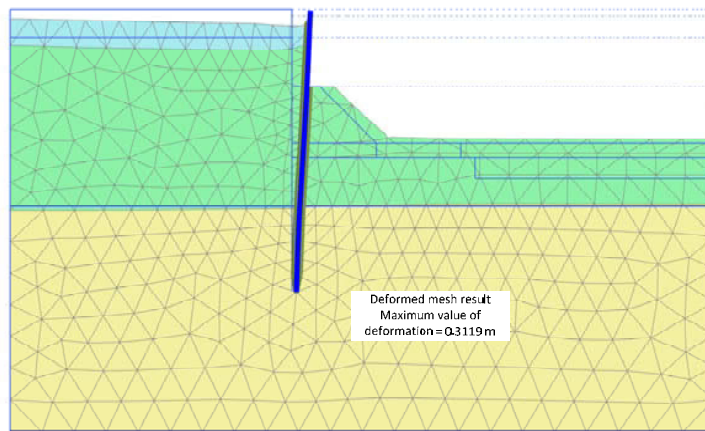
The simulation was conducted twice. The first was sensitivity analysis to find the appropriate modeling parameters suit to the real deformation. The last one was to find the solution to prevent excessive deformation continuously occurred. Three parameters were utilized for sensitive analysis, namely stiffness modulus, cohesion, and friction angle. The results of the simulation can be seen in Fig.6. The parameters used to obtain field condition in which a 310 mm lateral deformation occurred are described in Table 2. Only layer 1 and layer 2 that significantly have effect of the wall deformation.

Fig. 6. Back analysis result

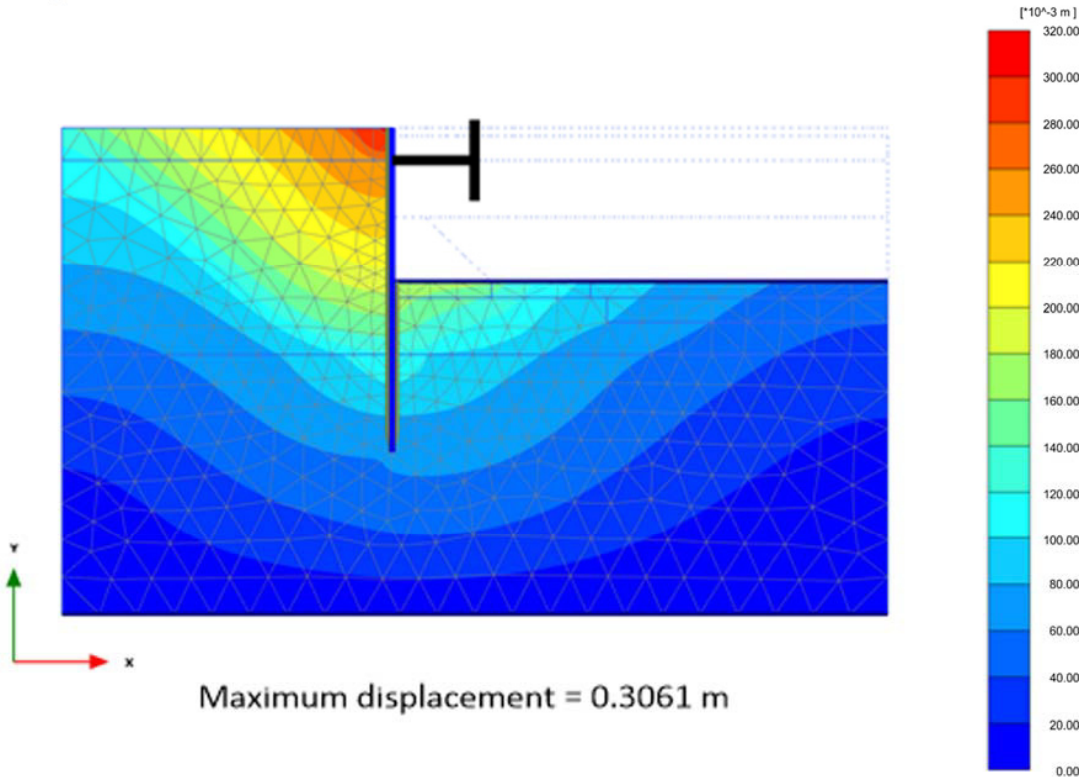
Fig. 7. Displacement distribution after strut installation

To prevent continuous deformation, strut is the most favorable structural counter measure. Strut can be installed without time consuming and the material is easily found in the surrounding construction site. The finite element modeling is also utilized to predict the behavior of the excavation system when the strut is installed. The results of

the simulation can be examined in Fig.7. It can be seen clearly that the excessive deformation is blocked at about 300 mm. it means that no additional deformation occurs.

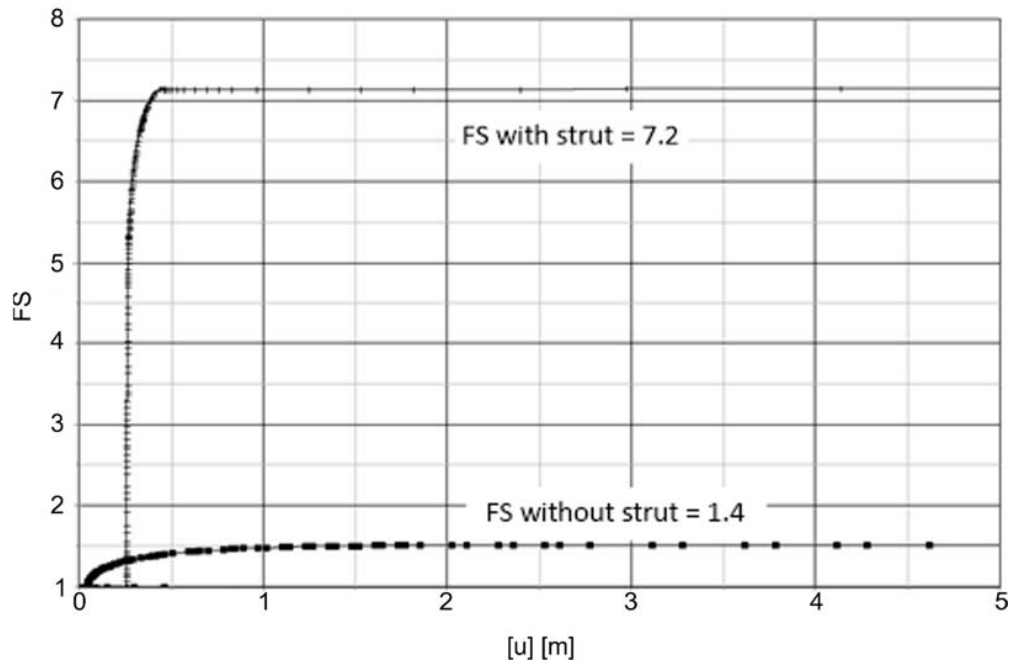
Fig. 8. Factor of Safety FS of the retaining wall system before and after back analysis

The proposed solution to prevent continuous excessive deformation works well. It can be seen in Fig.8 that safety factor increases significantly when the strut is installed, even with very weak soil parameters. The excessive deformation does not continue to occur. In the field, excessive deformation and strut installation have changed the construction methods. The use of the building column to support the strut requires top down basement construction process (Fig.9). The lower basement should be constructed after the upper basement completed.

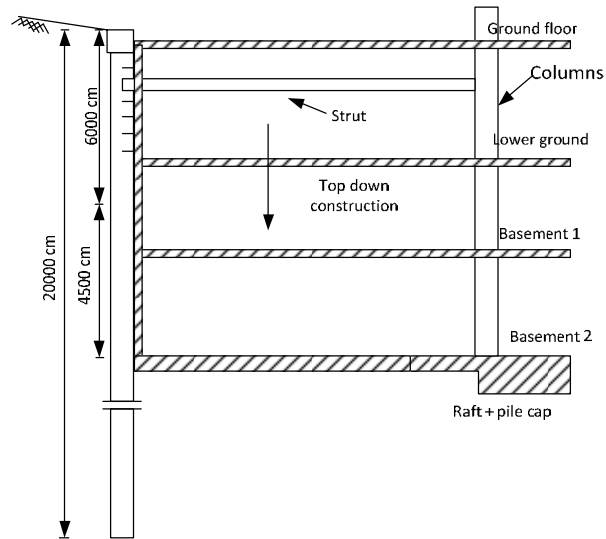
Fig. 9. Top down basement construction process
