Sustainable Civil Engineering Structures and Construction Materials, SCESCM 2016

Back calculation of excessive deformation on deep excavation

M. F. Ma'ruf^{a,*}, H. Darjanto^b

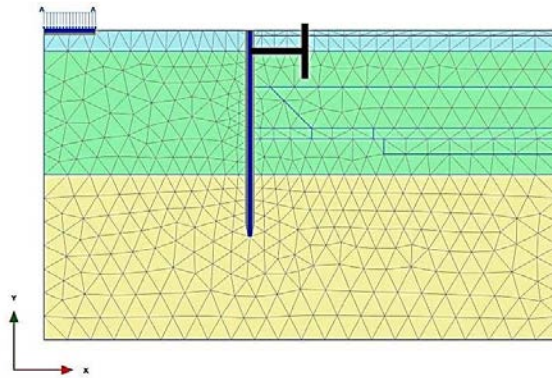
Geometrical modeling of the excavation in PLAXIS is presented in Fig.5. The plane strain model was applied with 15 nodes for meshing. The uniform loading was applied to represent the 3 stories building. While fixed strut was installed to prevent continues deformation.

Fig. 5. Geometrical modeling and meshing in PLAXIS
